Ersa i-CON soldering station display backlight replacement

Shows how to replace failed display backlight LEDs in Ersa i-CON 1 and i-CON 2 soldering stations.

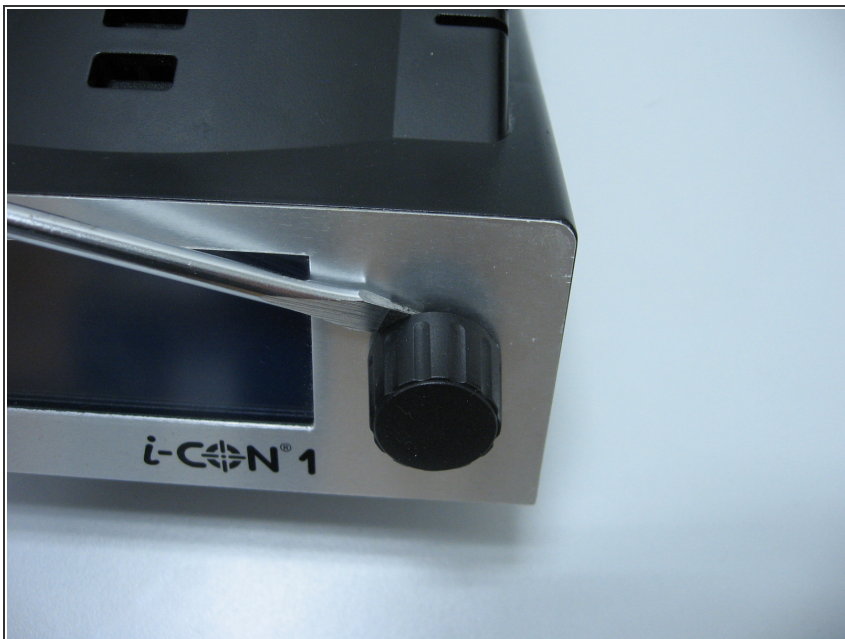
Step 1 — Pull off control knob

- Pull off the control knob using flat-head screwdriver or similar tool.

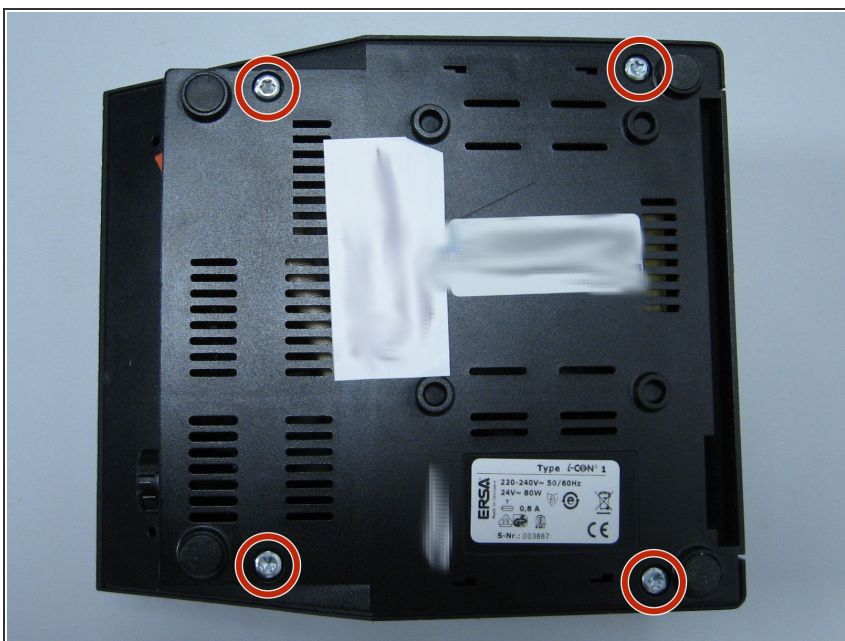
Step 2 — Remove bottom screws

- Flip the station over and remove 4 screws with T20 screwdriver. Then flip the station back and pull up the top cover.

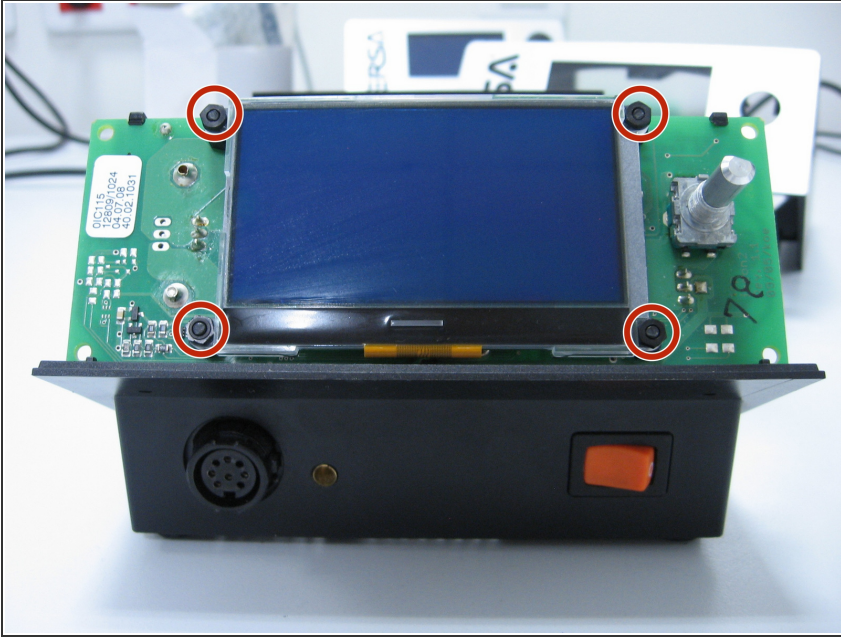
Step 3 — Remove display nuts

- Remove 4 plastic nuts around the display with pliers or similar tool.

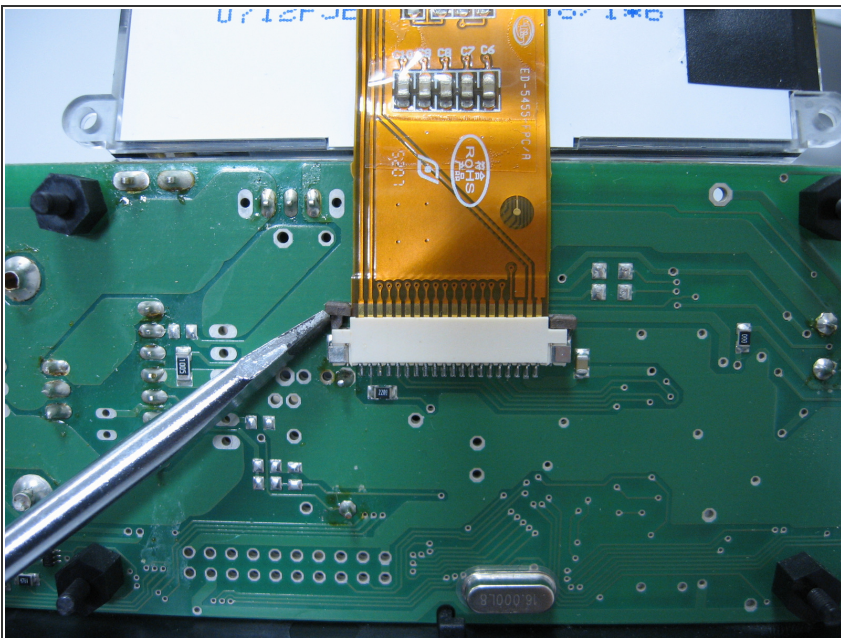
Step 4 — Disconnect the display

- Carefully flip the display upwards. Then loosen the flat cable connector by pushing up small brown bars on both sides. Pull the flat cable from the connector.
- ⓘ If you have replacement display, you can simply connect in the new one. Then you can assemble the station back together and you're done.

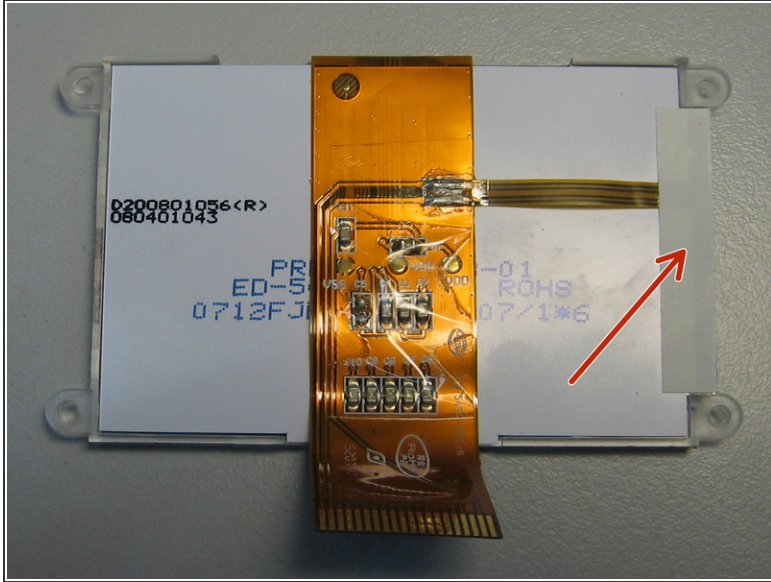
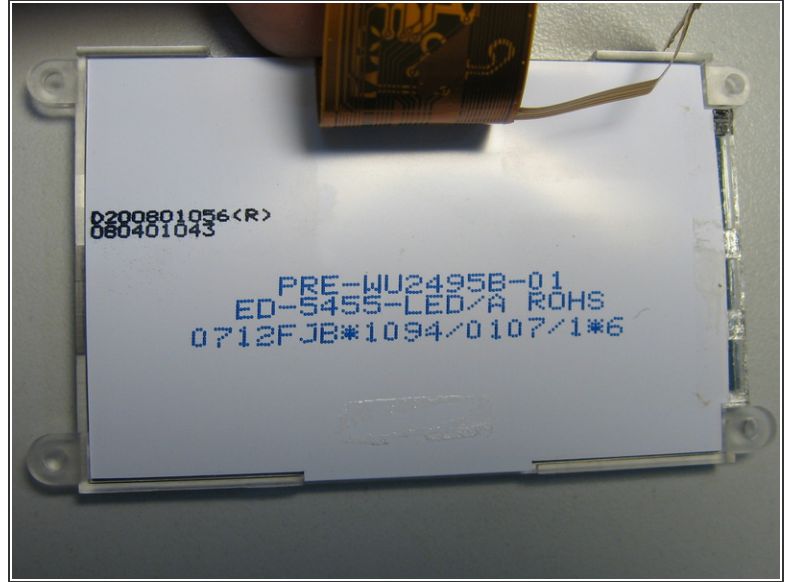
Step 5 — Locate the display backlight

- Display backlight is hidden under white tape on the right side.
- The second photo shows markings on the display.

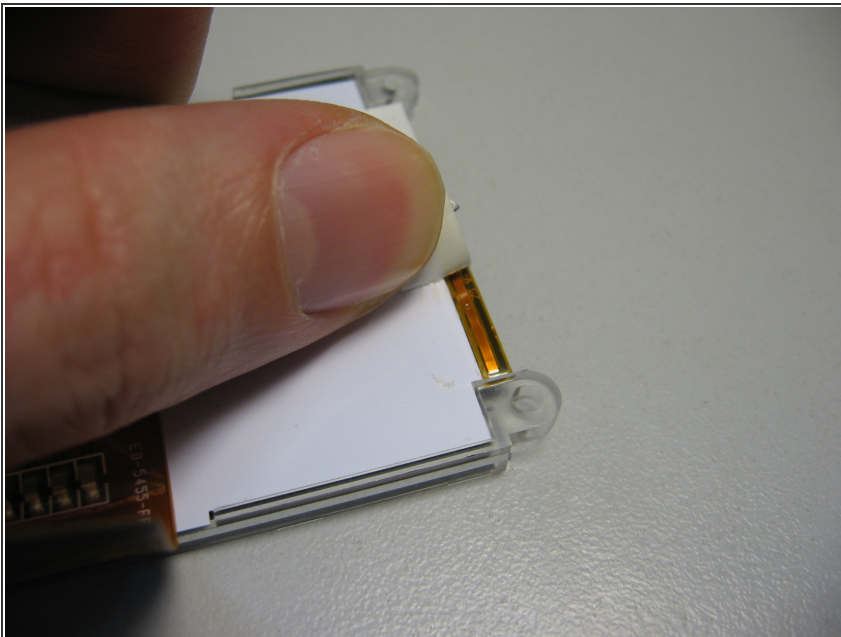
Step 6 — Remove cover tape

- Carefully remove the white cover tape. It's best to use a knife or similar tool.
- ⚠ Make sure the golden flexible circuit board strip doesn't bend upwards along with the cover tape!

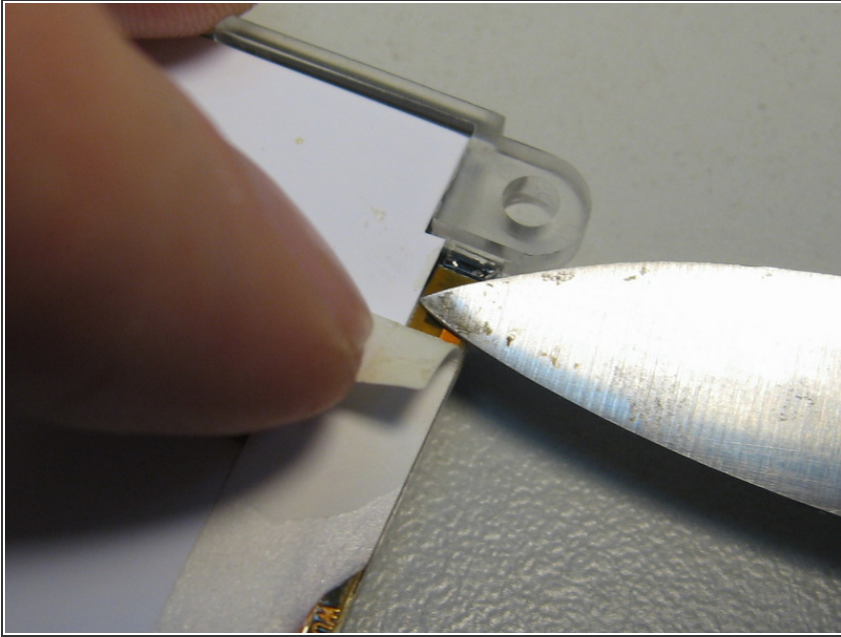
Step 7 — Remove cover tape

- You can hold down the circuit strip with a knife or similar tool to unstick it from the cover tape.
- ⓘ Be careful if you decide to wash away strip glue residue with alcohol. If it seeps between various layers inside the display area, it may develop unsightly spots.

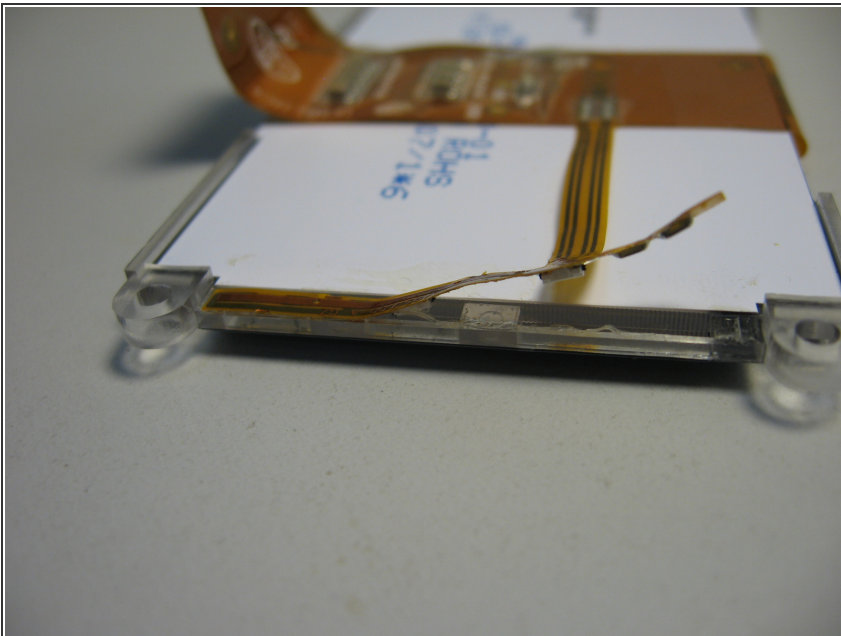
Step 8 — Unstick the circuit strip from the base

- Carefully unstick the circuit strip from the plexiglass base with knife.
 - The strip is glued in with a thin transparent double-sided tape. Make sure the tape stays on the plexiglass base. If it tears away along with the strip, use knife tip to push it back onto the plexiglass.
- ⚠ Try to bend the strip as little as possible, otherwise it will be difficult to seat it back in properly later.

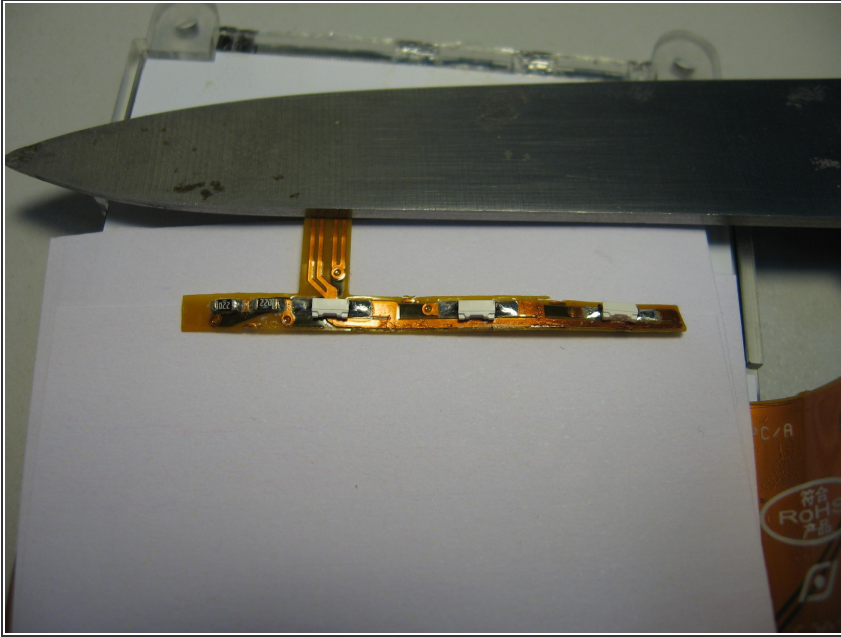
Step 9 — Desolder original backlight LEDs

- Fold the circuit strip onto display's back cover and weigh it down. This will reveal the faulty original LEDs and some resistors.

⚠ Place some heat-resistant material under the strip before soldering. If you melt display's plastic back cover, it will develop unsightly spots. I'm using several sheets of paper in the photo.

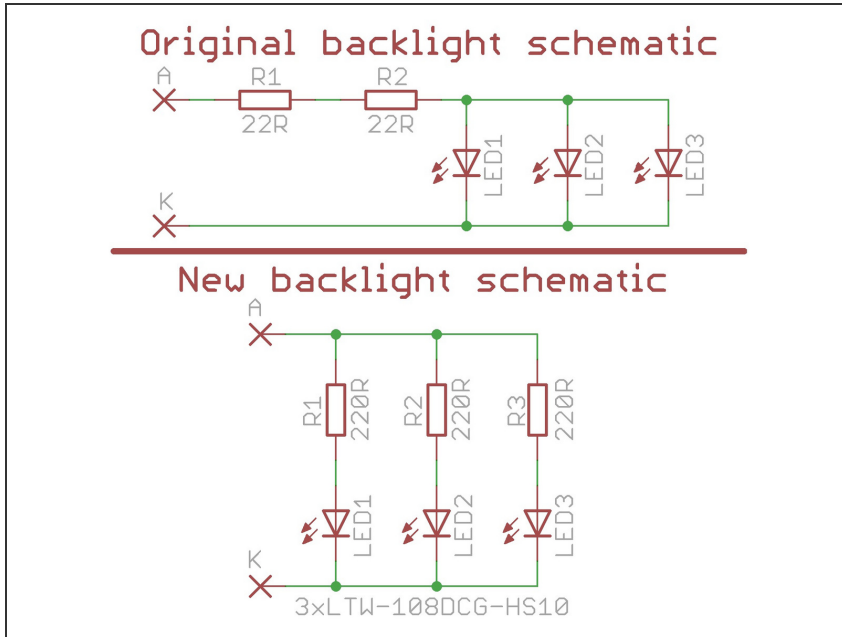
Step 10 — Backlight schematics

- I analyzed original backlight connections and it's apparent why it fails: Chinese comrades who designed the display wanted to save some money and/or space and connected the LEDs in parallel.
- Of course, every LED has slightly different threshold voltage. As a consequence, one of them draws more current and fails (burns open) prematurely. The remaining two LEDs are then subjected to even higher currents and burn soon afterwards, too.
- Thus I decided to change the connection according to the lower schematic - I shorted the original 22R resistors and put a 220R resistor in series with each new LED.

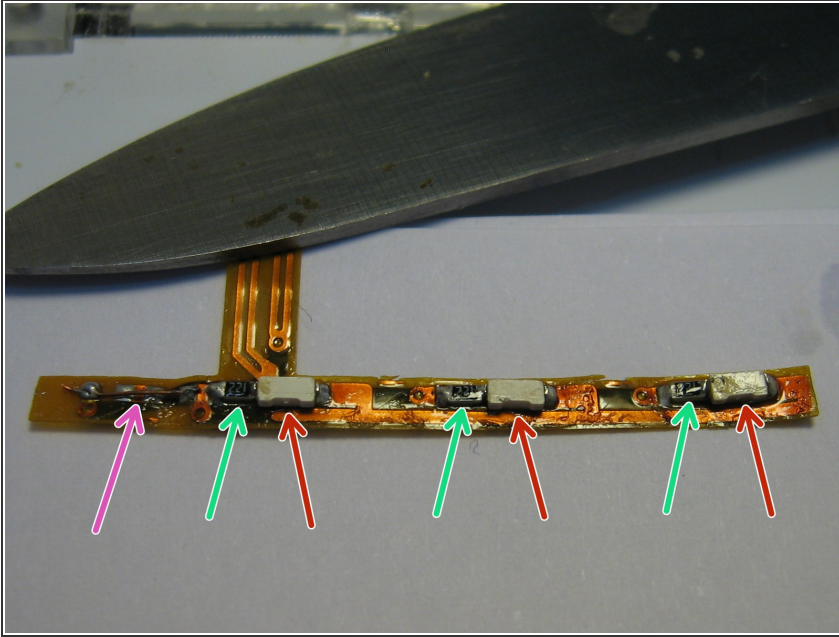
Step 11 — Solder in new components

- Fortunately, there is enough room on the strip to solder in new LEDs (red arrows) along with their 220R resistors (green arrows) on the original solder pads. It's ugly, but it works. You have to use resistors in 0603 package to fit them into the available space.
- Note that I also desoldered the original 22R resistors and shorted their pads with a thin wire (purple arrow).
- You can verify that all three new LEDs work by connecting a 5V power supply onto "A" and "K" pads on the strip.

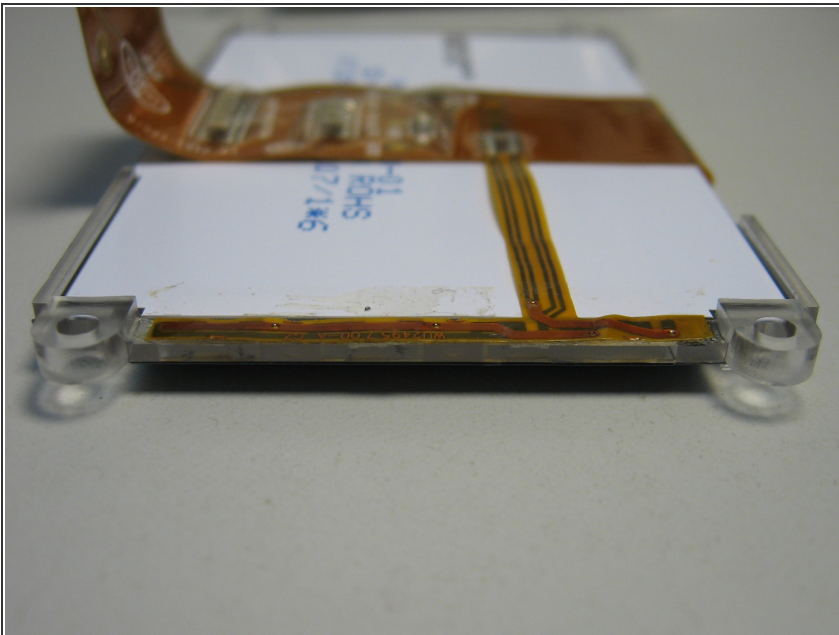
Step 12 — Seat the strip back onto base

- Stick the circuit strip back onto plexiglass base.
- ⚠ Remember that the new components are a bit wider, so make sure the strip doesn't bulge or stick out anywhere. If it doesn't fit properly, unstick it and try a slightly different position.

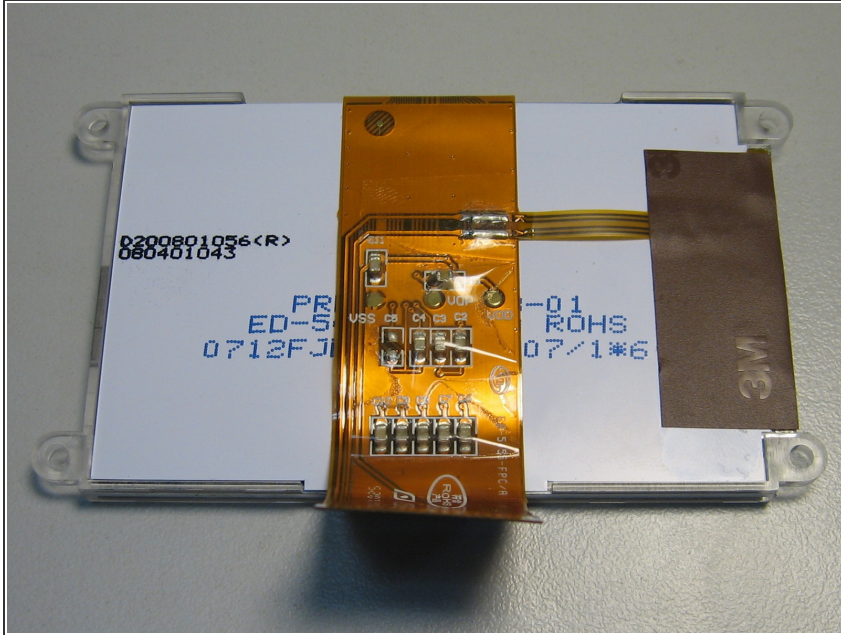
Step 13 — Secure the strip with new cover tape

- Secure the strip in place with new tape cover. I used brown electrical tape in this photo.
- Then you can reassemble the soldering station.

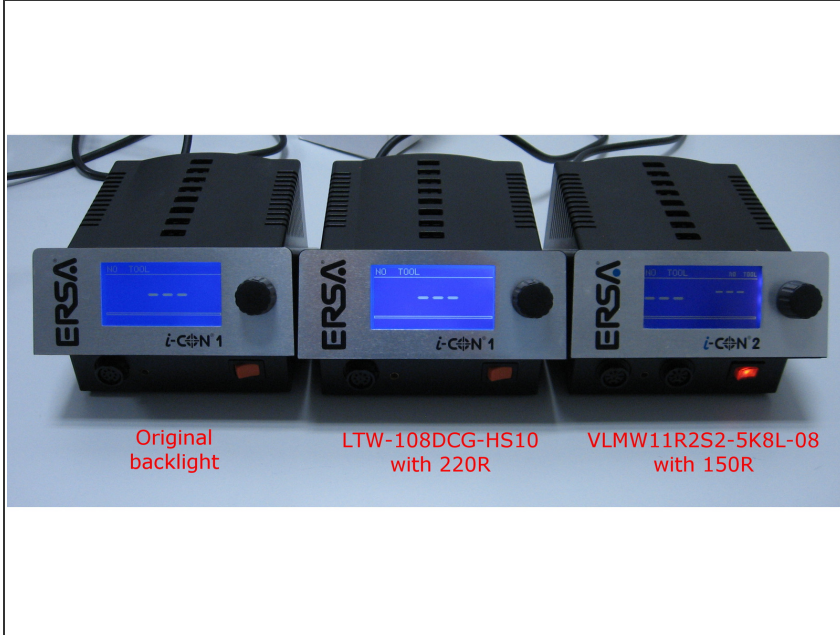
Step 14 — Final result

- Here you can see comparison of original (left) and new backlight (center). The new backlight is slightly brighter than the original; you can use larger resistors (270 or 330R instead of 220R) to lower the brightness.
- I also experimented with general-purpose VLMW11R2S2-5K8L-08 omnidirectional LEDs. You can see the result on the station on the right - the display is rather dim and there is significant backlight bleed on its right edge, where the LEDs are located. Thus I recommend to use only directional, right-angle LEDs like LTW-108DCG-HS10.
- Since new LEDs need lower current to achieve similar light output, they should outlast the soldering station. This "trick" is generally applicable; high-brightness LEDs always generate more light at 2 mA than ordinary LEDs at 20 mA. At the same time, they consume less power, generate less heat and last much longer.
